HRM Test Report

Prepared for: Protective Structures, LLC

DRAFT- 25 June 2013

During the week of 6 – 10 May 2013, Applied Research Associates (ARA) conducted three blast exposures of various Hardened Resistant Module (HRM) or Blast Resistant Module (BRM) structures at the ARA operated Pecos Research and Testing Center (PRTC), located 18 miles southeast of Pecos, TX.

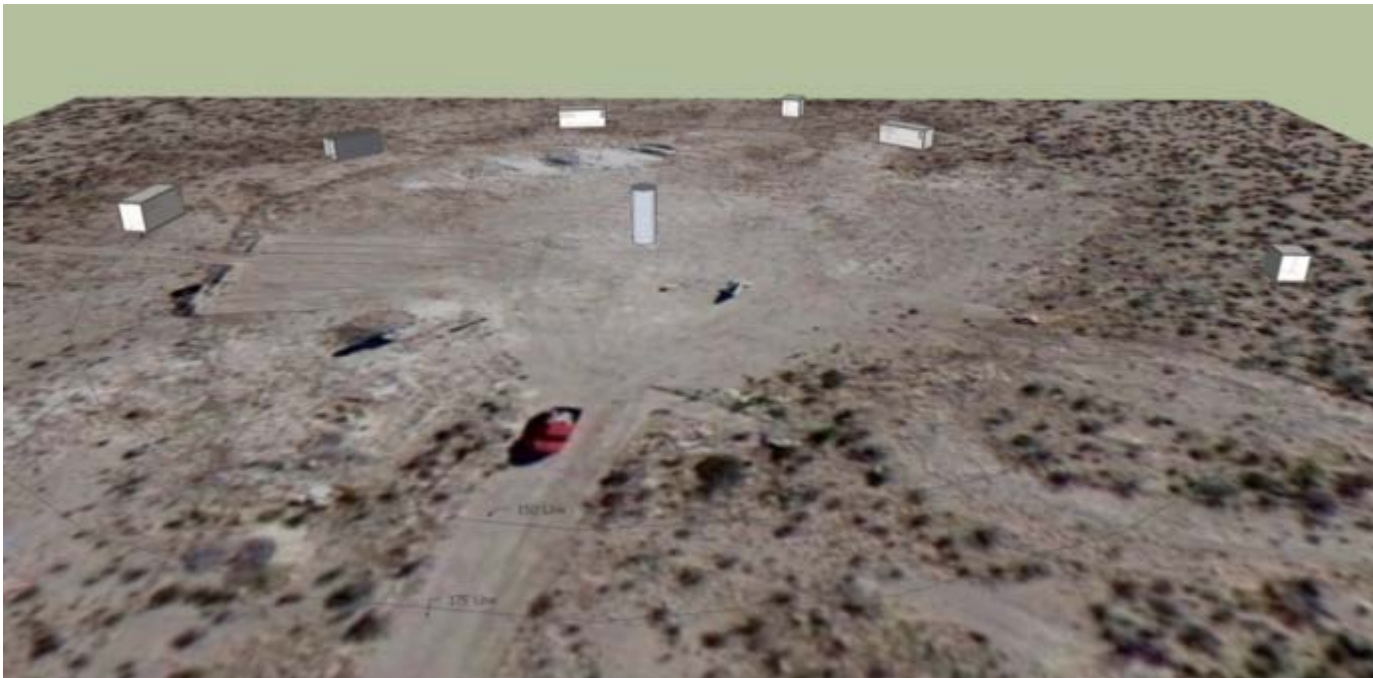
Basic test layout showing relative HRM and charge locations

The exposure charge was a nominal 9,000 lb of enhanced Ammonium Nitrate / Fuel Oil (ANFO) with an approximate TNT equivalence of 0.89. The charge was detonated in a vertically oriented metallic culvert with top initiation. The HRM stand-off distances were either 150 or 175 ft.

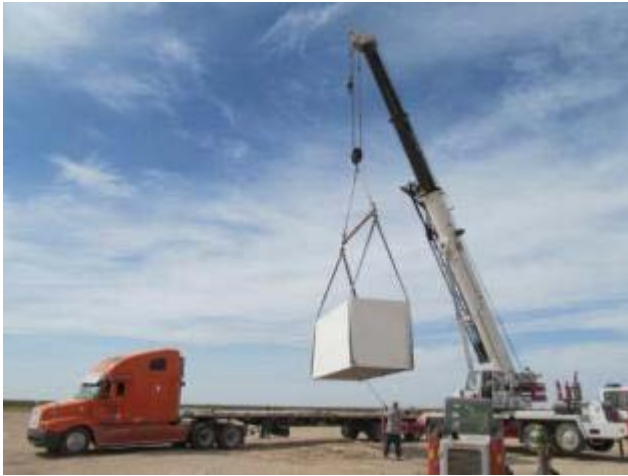
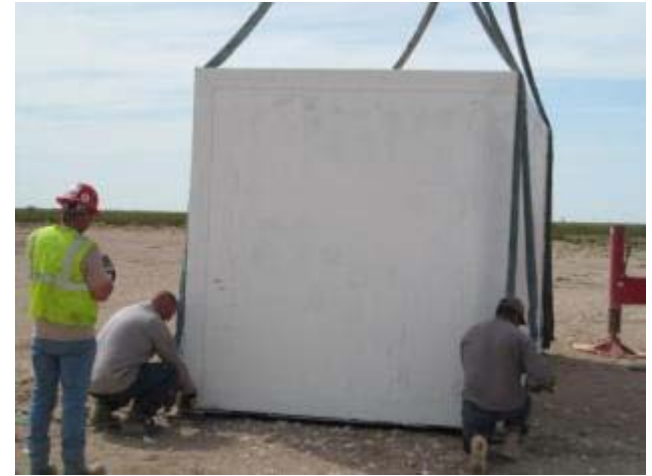
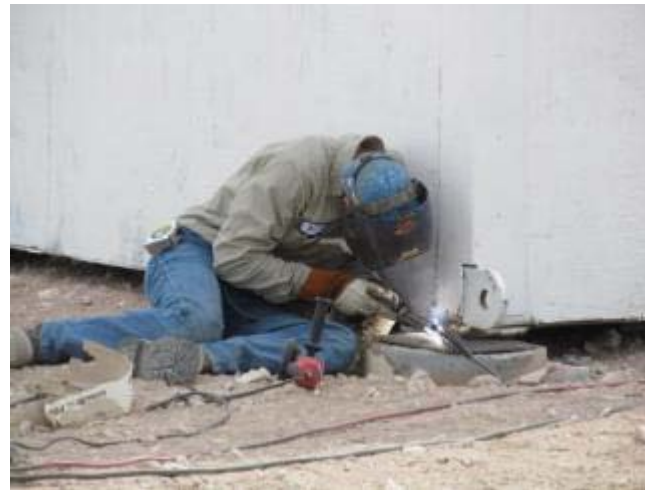
Typical HRM off-loading, final positioning, and securing to support pilings

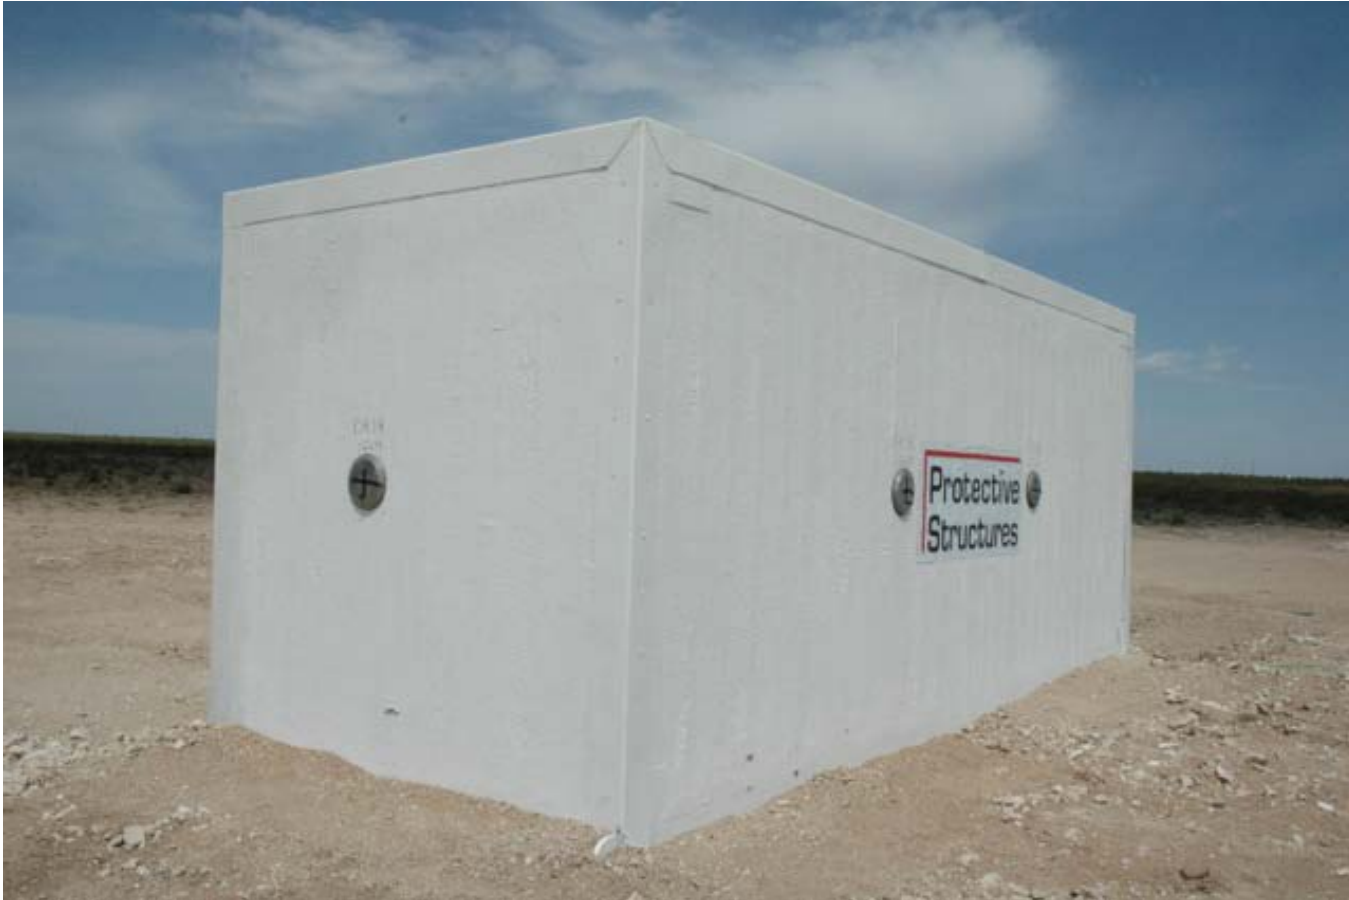
BRM 2 as deployed

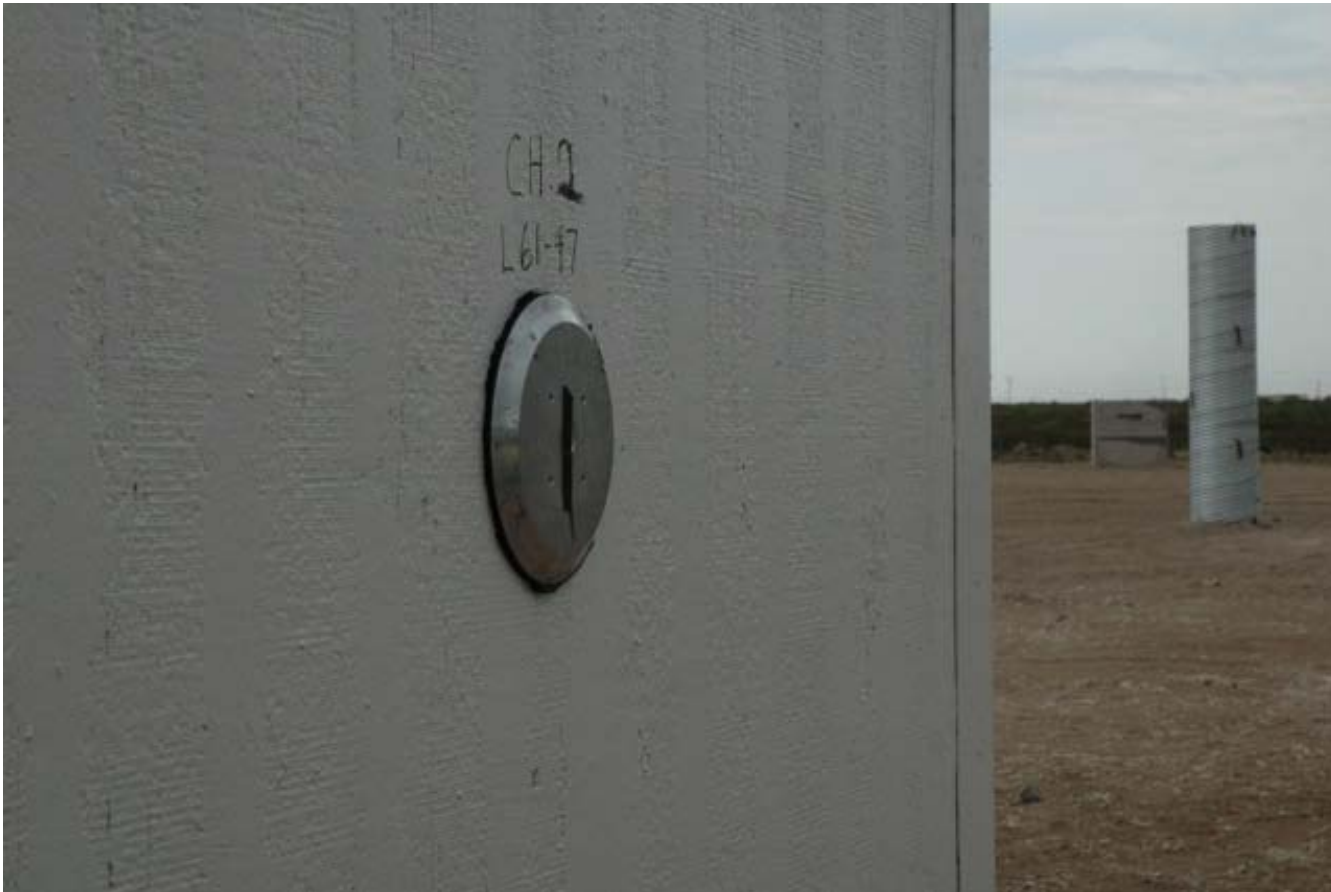
Charge as viewed from incident BRM 2 transducer

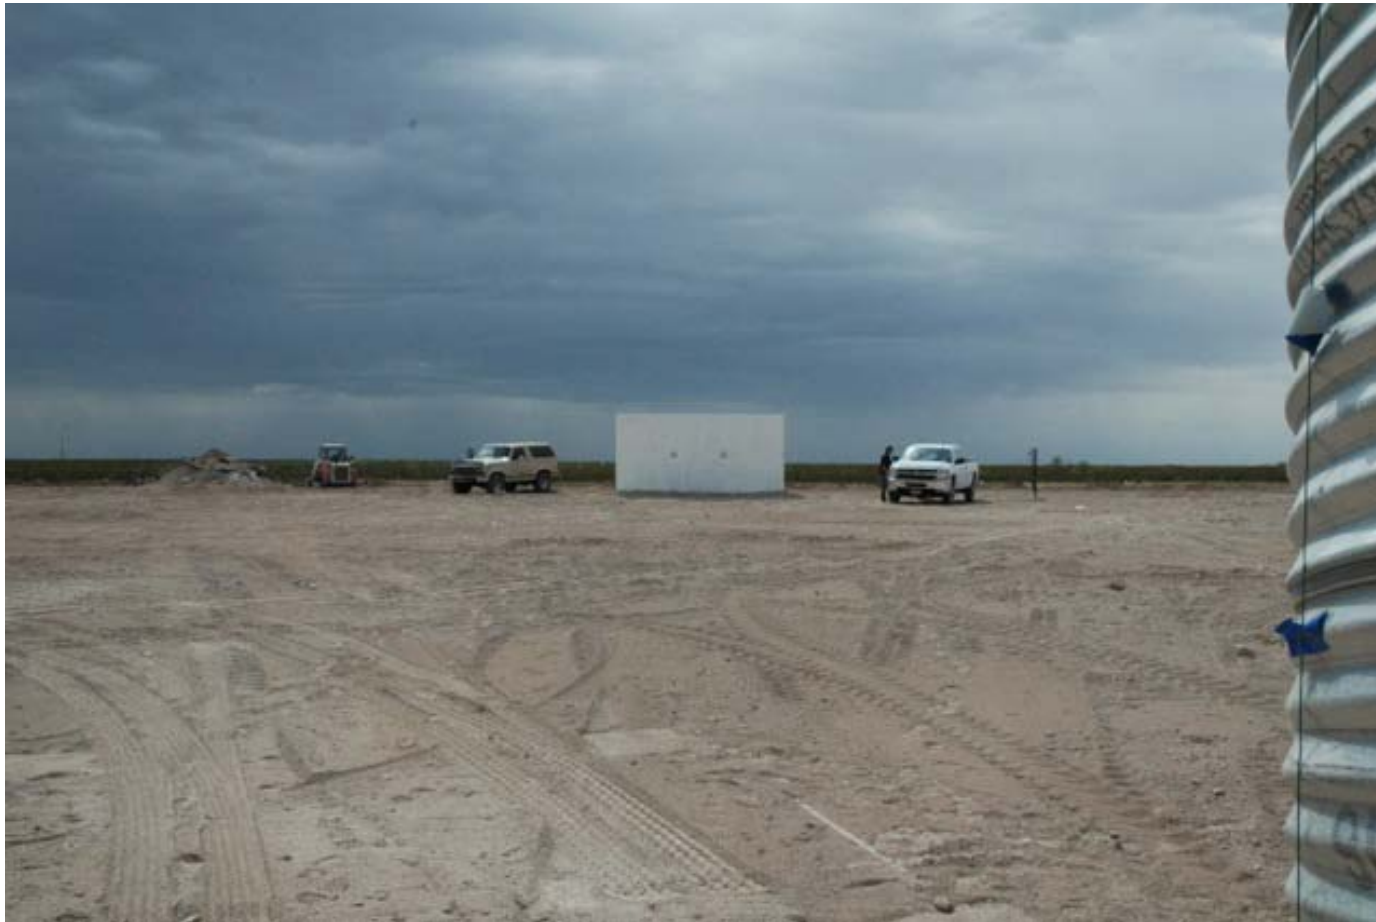
BRM 3 as viewed from charge

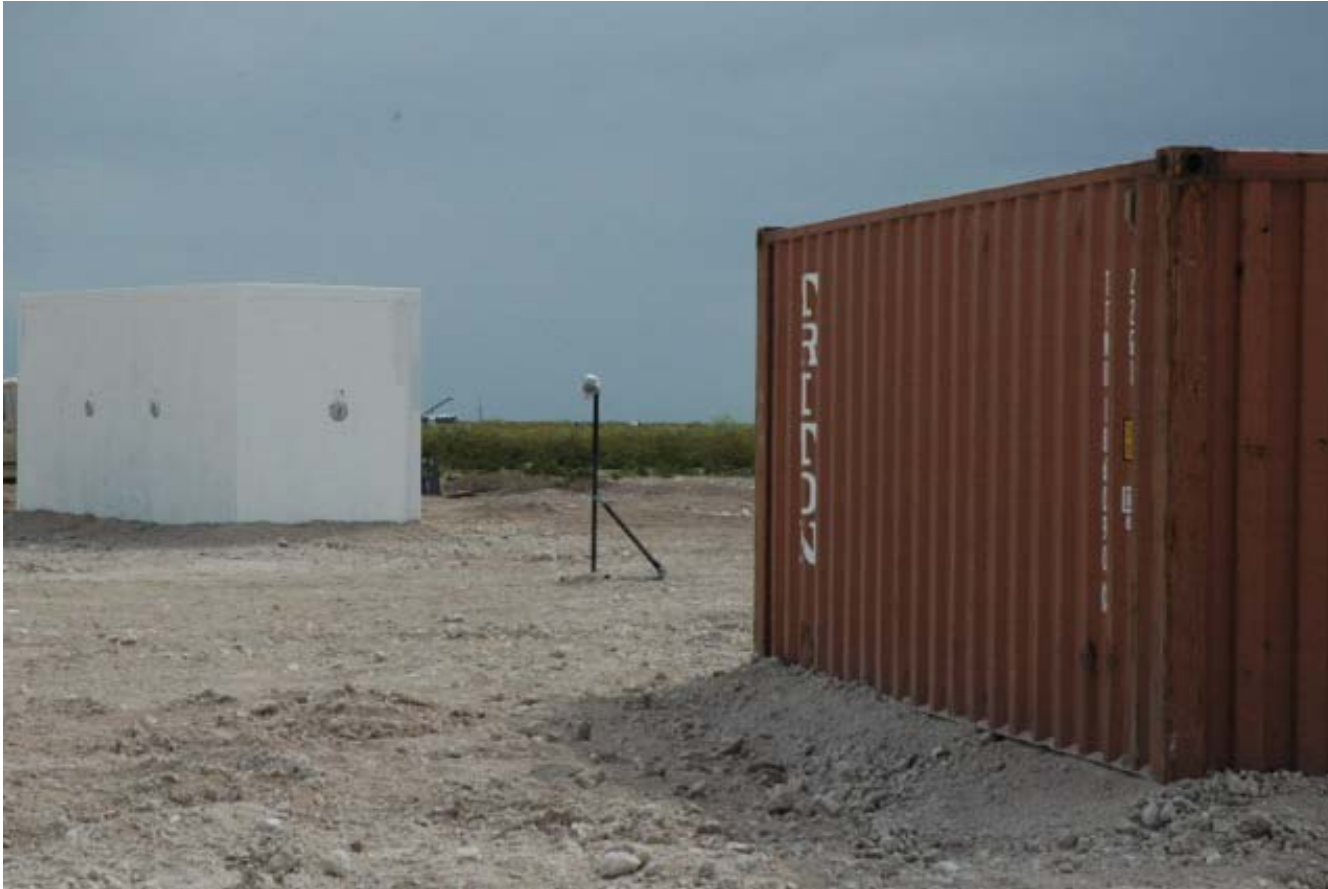
BRM 3, incident transducer radial, and connex container as deployed

- Three incident transducers mounted at 150, 175, and 200 ft. on a single radial
- BRM 1 – 2 x reflective, 2 x incident
- BRM 2 – 2 x reflective, 1 x incident, 1 x internal
- BRM 3 – 2 x reflective, 2 x incident, 1 x internal
- Shipping Connex – 1 x internal

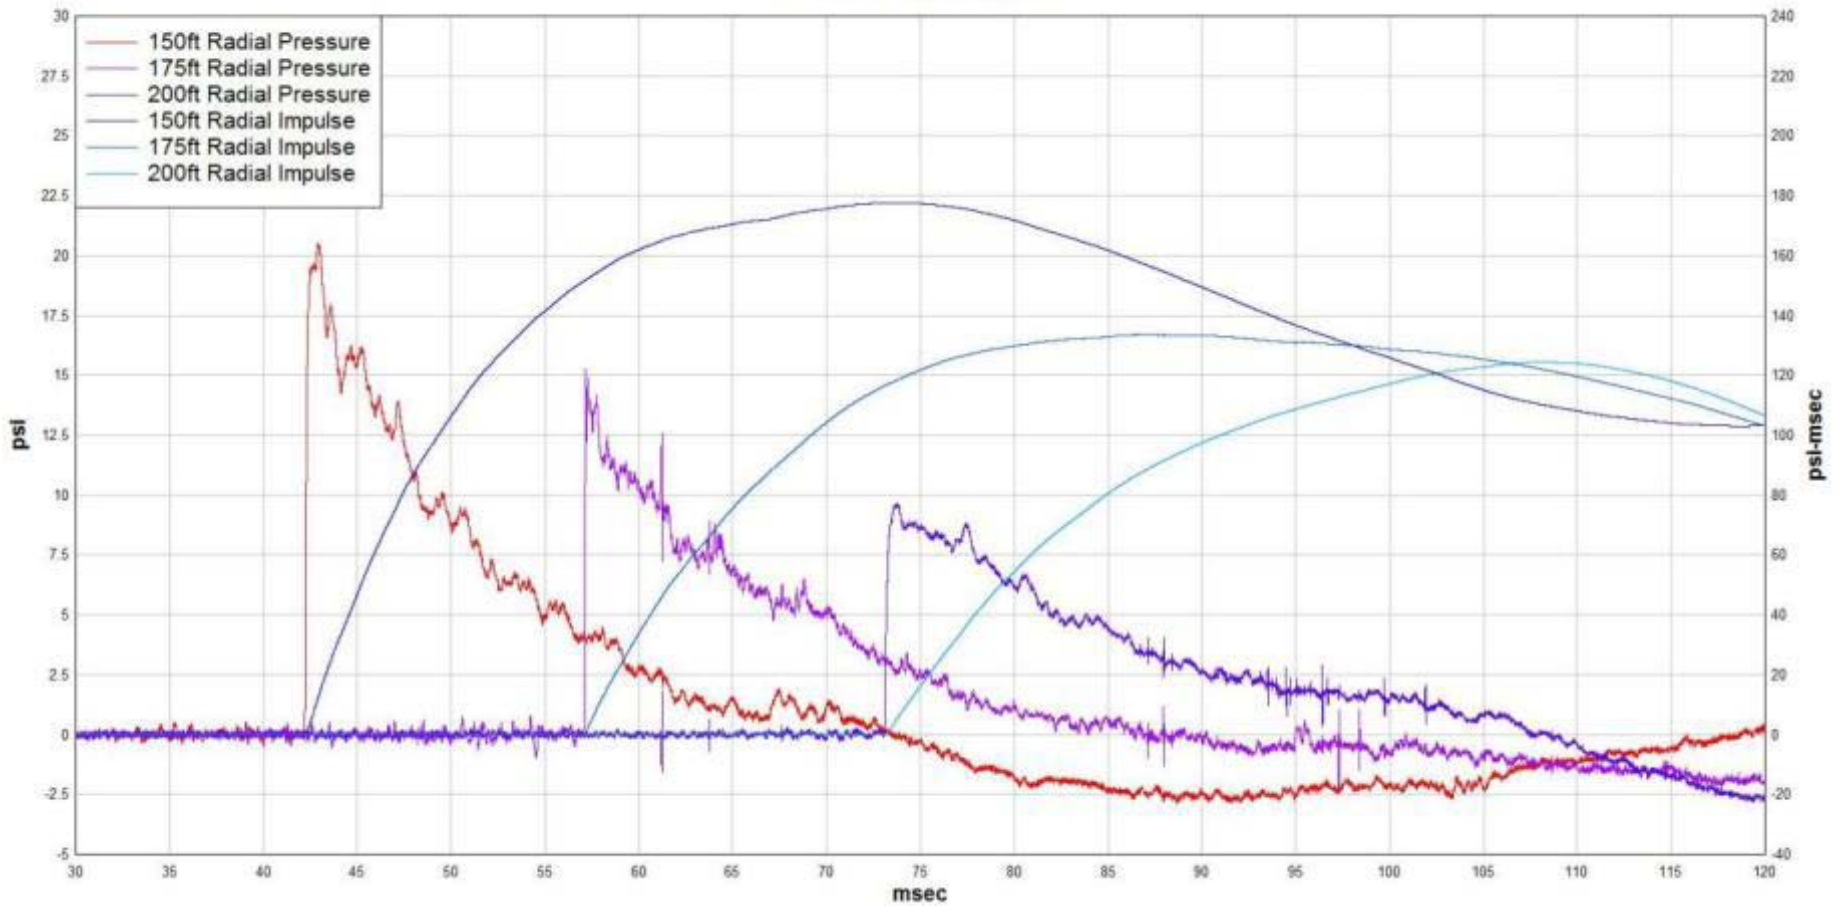
Incident Radial

**BRM Structure Testing
 May 7 2013
 Free Field Radial Incident**

| Location | Max Pressure | Total Impulse | Positive Phase Duration |
|---|---|---|---|
| • Incident Radial (150 ft): | 20.52 psi | 177.6 psi-msec | 31.3 msec |
| • Incident Radial (175 ft): | 15.29 psi | 133.5 psi-msec | 29.6 msec |
| • Incident Radial (200 ft): | 9.67 psi | 124.3 psi-msec | 35.3 msec |

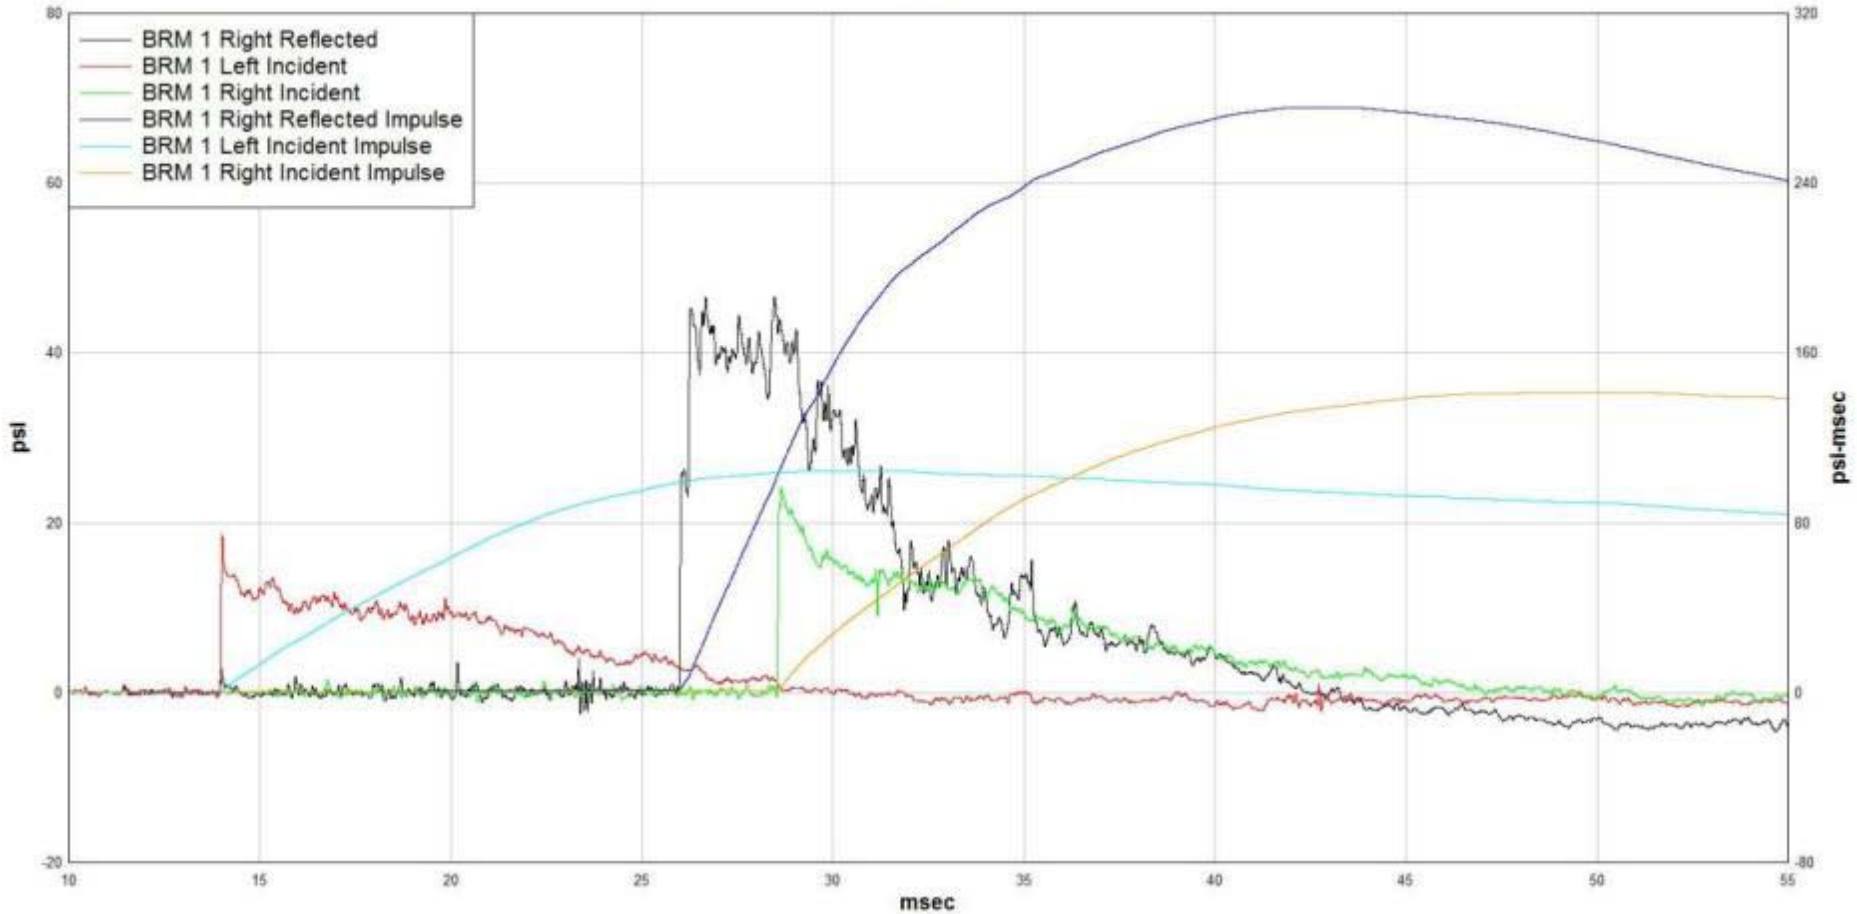
BRM 1 Reflected and Incident Pressures

BRM Structure Testing
May 7 2013
BRM 1

| Location | Max Pressure | Total Impulse | Positive Phase Duration |
|---|---|---|---|
| • BRM 1 Reflected Right: | 46.62 psi | 275.9 psi-msec | 18.0 msec |
| • BRM 1 Incident Left: | 18.58 psi | 104.8 psi-msec | 16.5 msec |
| • BRM 1 Incident Right: | 24.24 psi | 141.5 psi-msec | 20.5 msec |

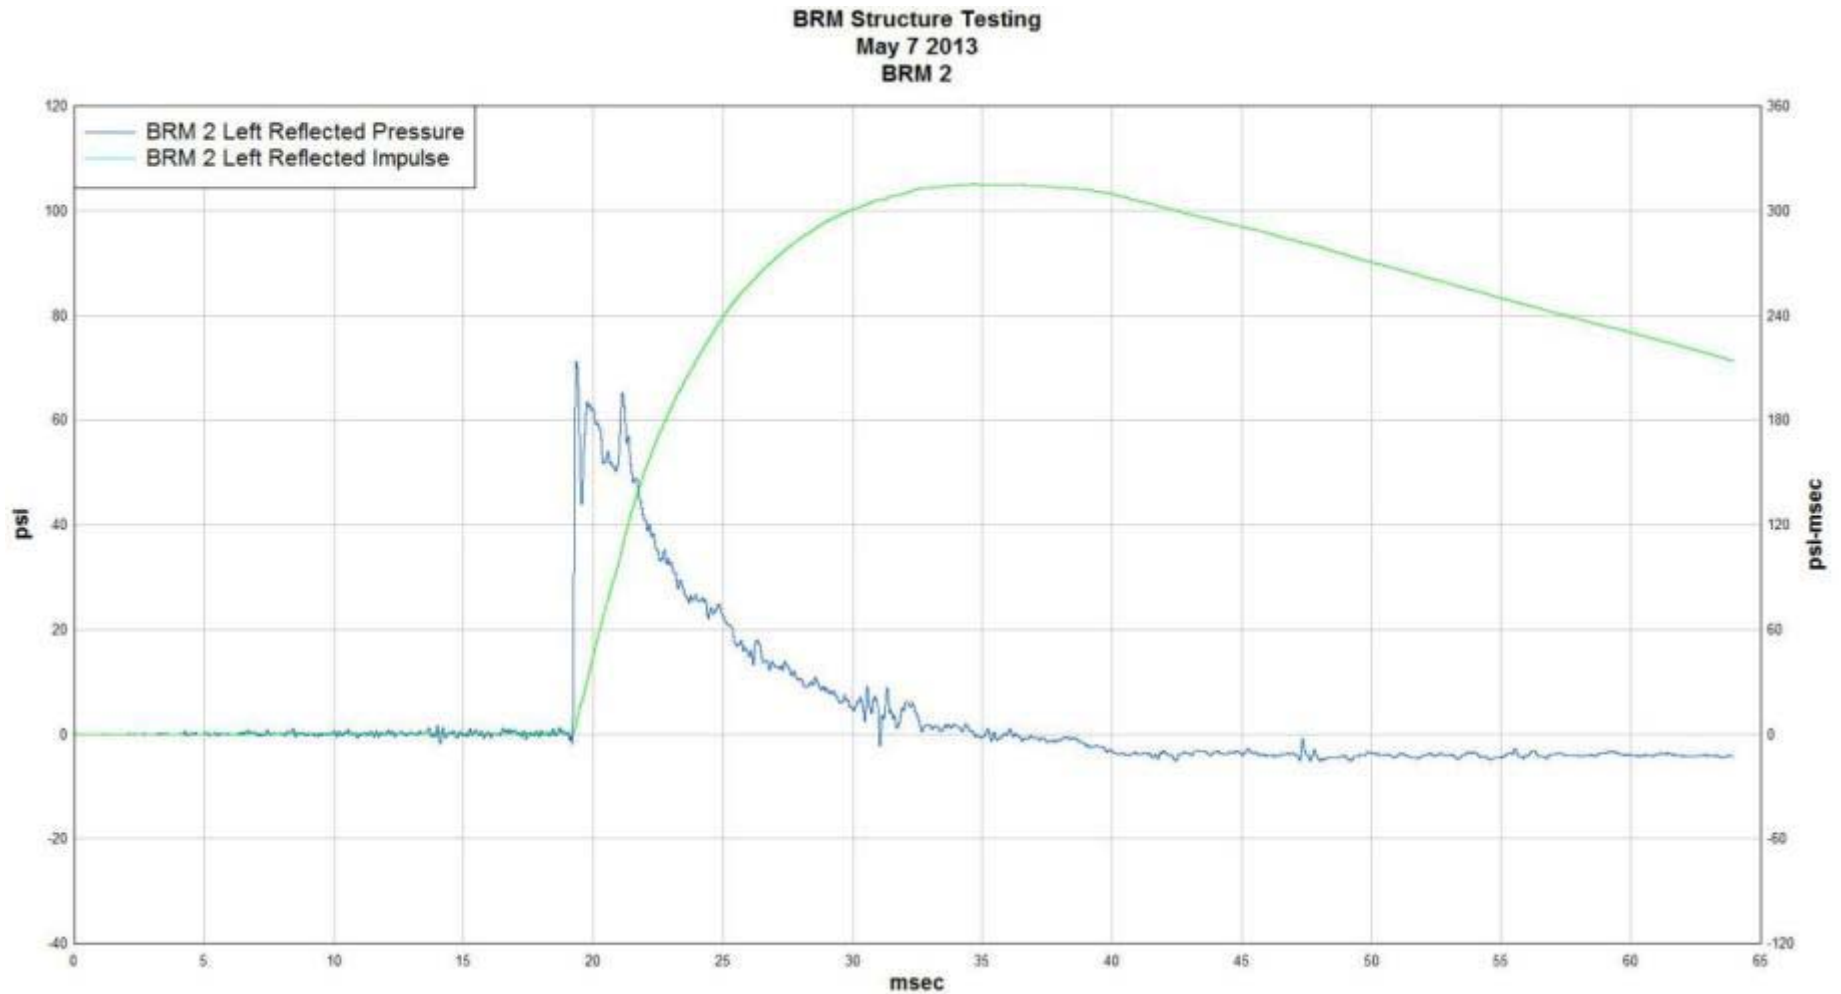
BRM 2 Reflected Pressure

| Location | Max Pressure | Total Impulse | Positive Phase Duration |
|---|---|---|---|
| • BRM 2 Reflected Left: | 71.17 psi | 315.2 psi-msec | 15.4 msec |

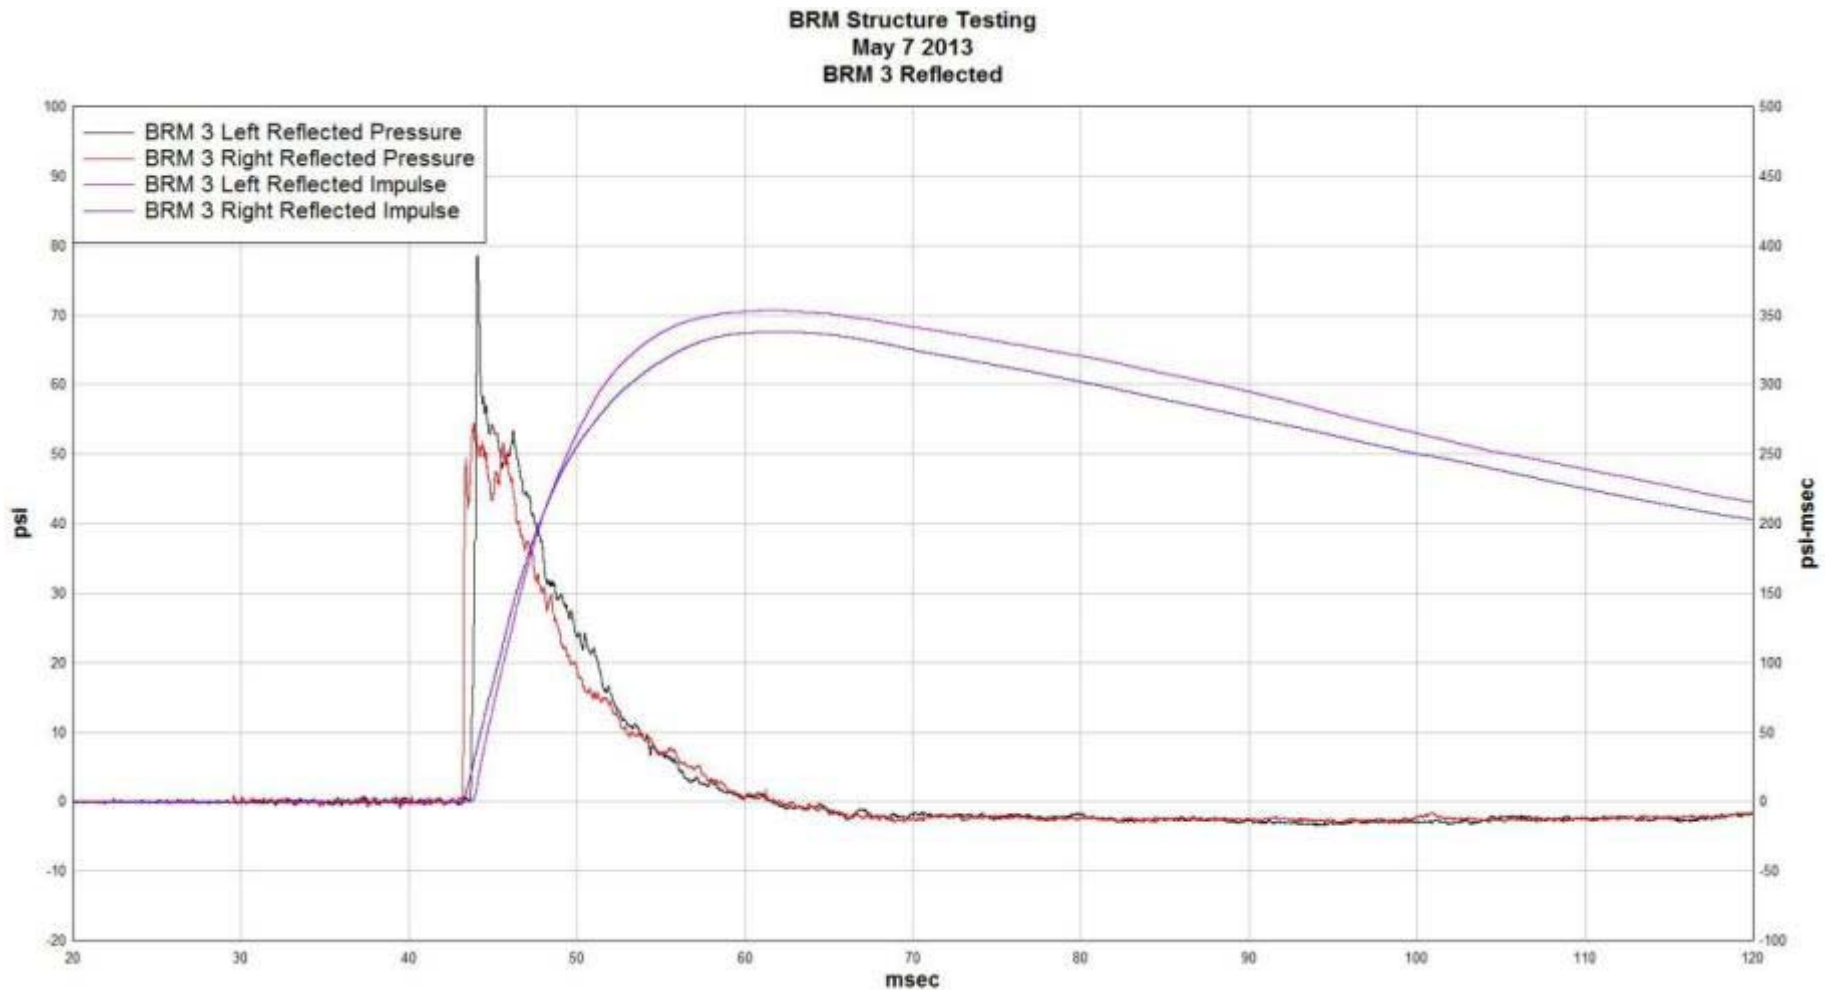
BRM 3 Reflected Pressure

| Location | Max Pressure | Total Impulse | Positive Phase Duration |
|---|---|---|---|
| • BRM 3 Reflected Left: | 78.55 psi | 353.5 psi-msec | 17.9 msec |
| • BRM 3 Reflected Right: | 54.54 psi | 338.2 psi-msec | 18.5 msec |

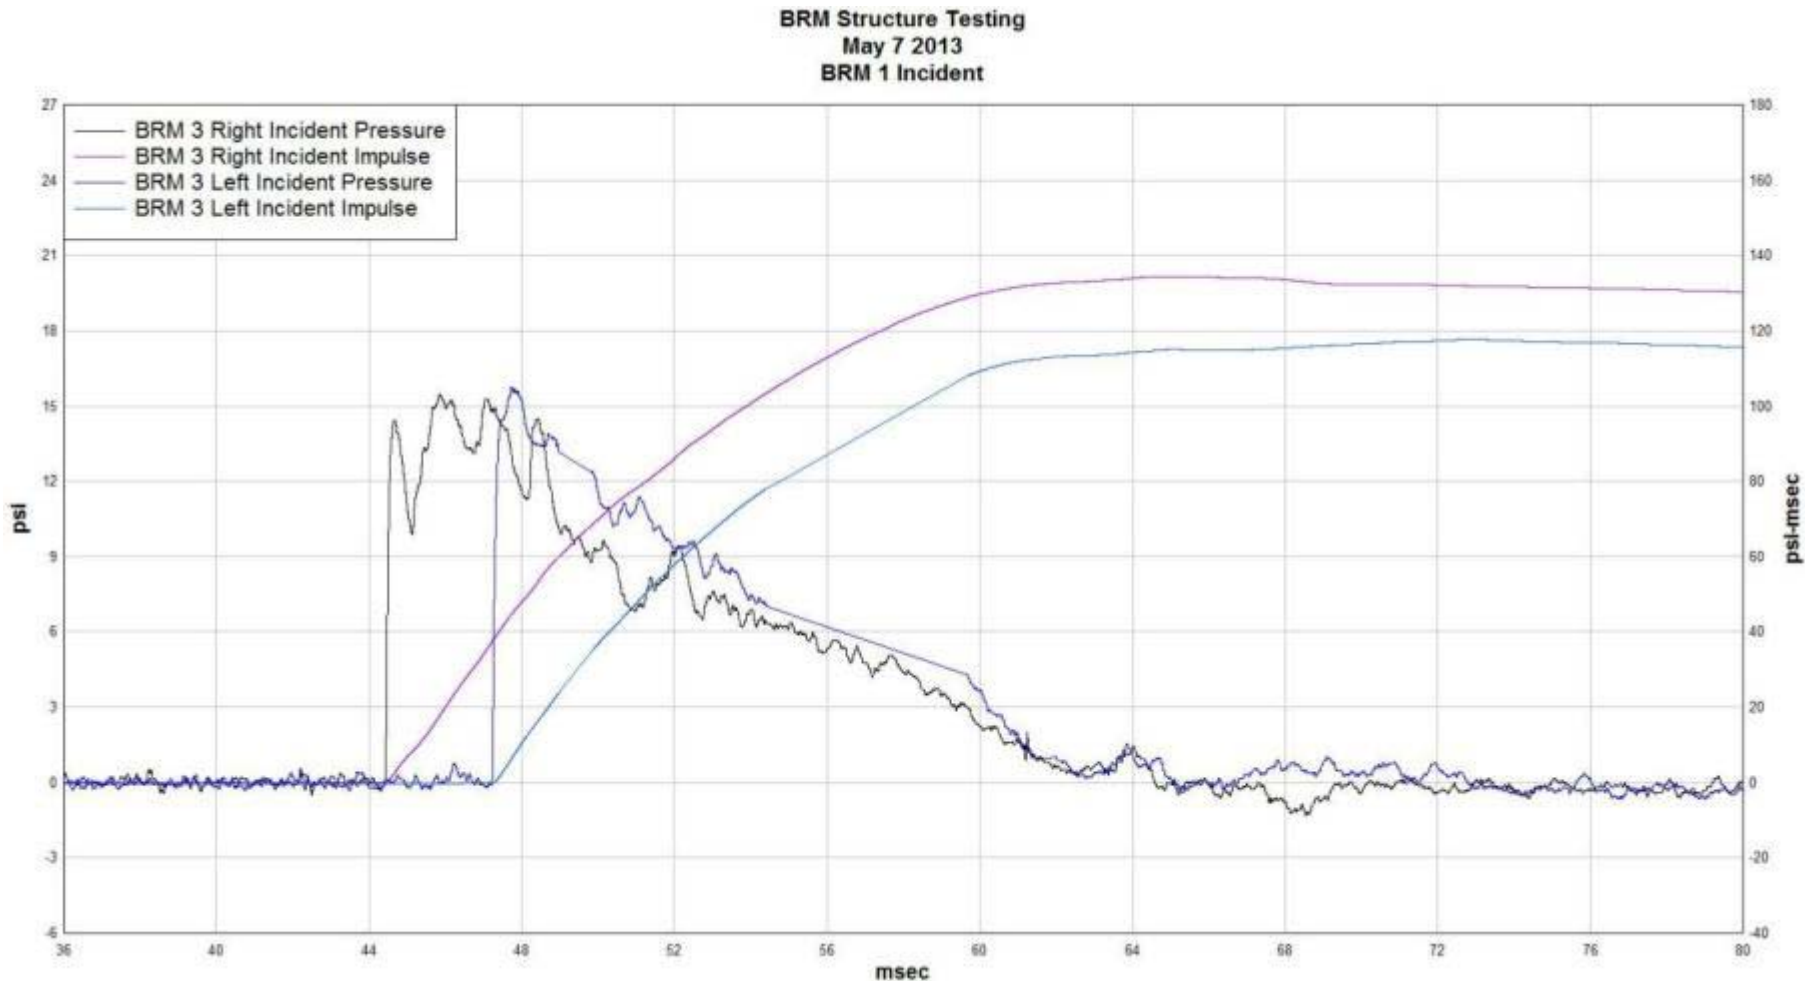
BRM 3 Incident Pressure

| Location | Max Pressure | Total Impulse | Positive Phase Duration |
|---|---|---|---|
| • BRM 3 Incident Left: | 15.75 psi | 117.6 psi-msec | 25.5 msec |
| • BRM 3 Incident Right: | 15.45 psi | 134.4 psi-msec | 19.7 msec |

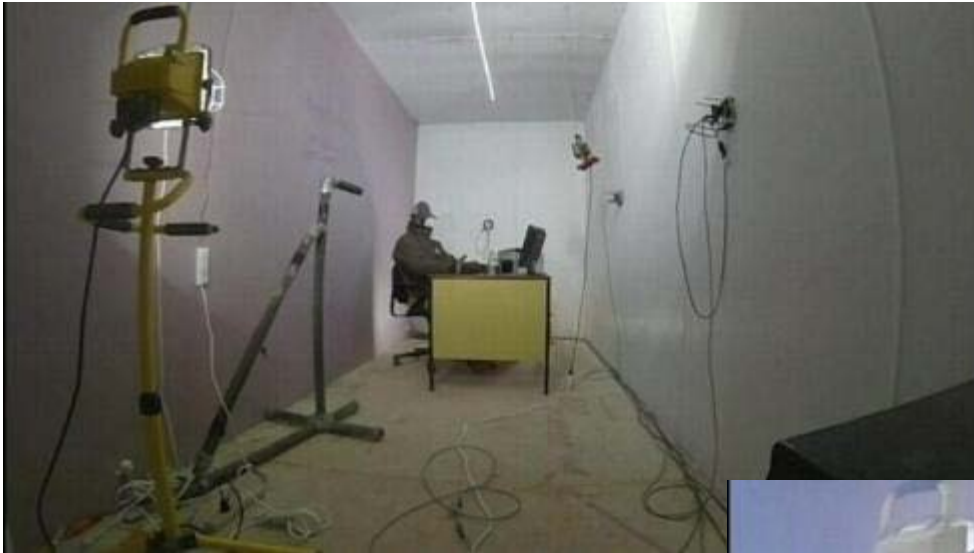
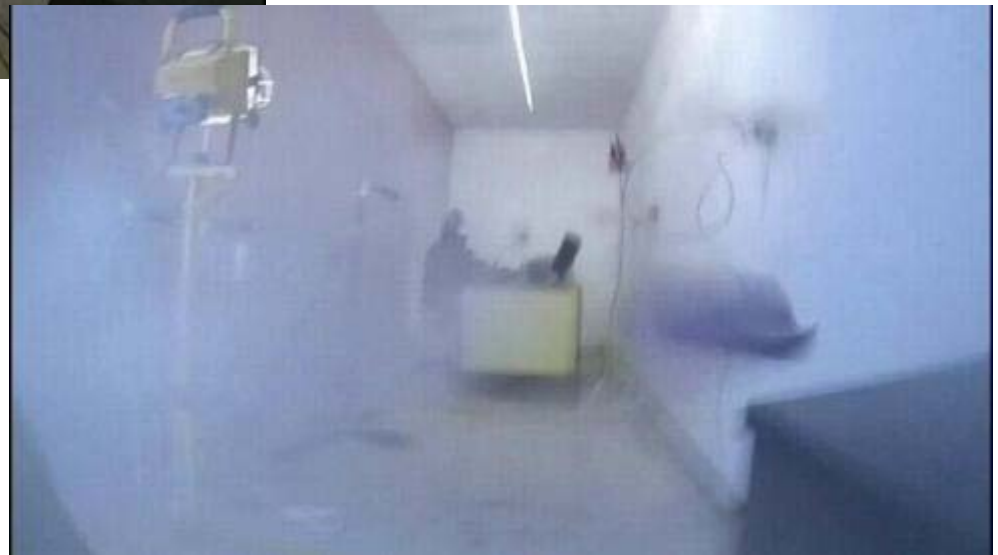
07 MAY 2013 Internal GOPRO BRM 3

- Phantom 7.1 color overview of entire arena (4,700 frames per second)- Failed to trigger on 07 May test.
- Phantom 7.3 black and white detail view of BRM 3 and Connex (5,000 frames per second)
- BRM 3 – Internal GOPRO camera (240 frames per second) monitoring human surrogate
